Blast triggered landslide at Steinvik, Tana, Norway

Samson A. Degago

The Project Fv. 98 Torhophøyden – Smalfjordbotn (98 MNOK)

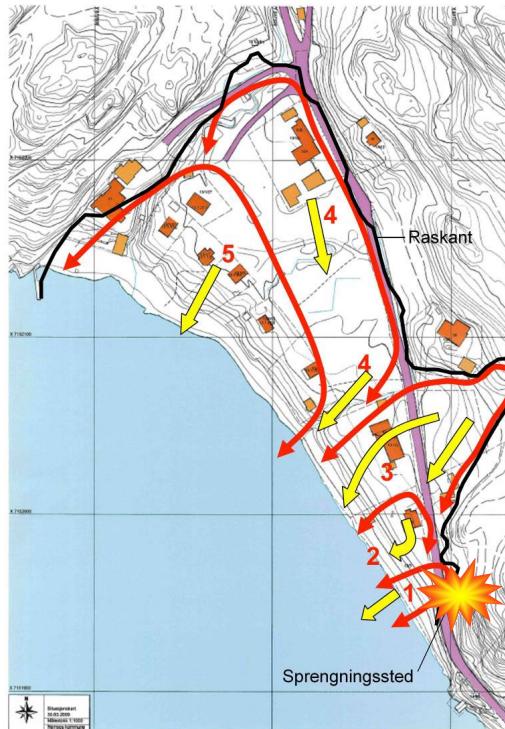
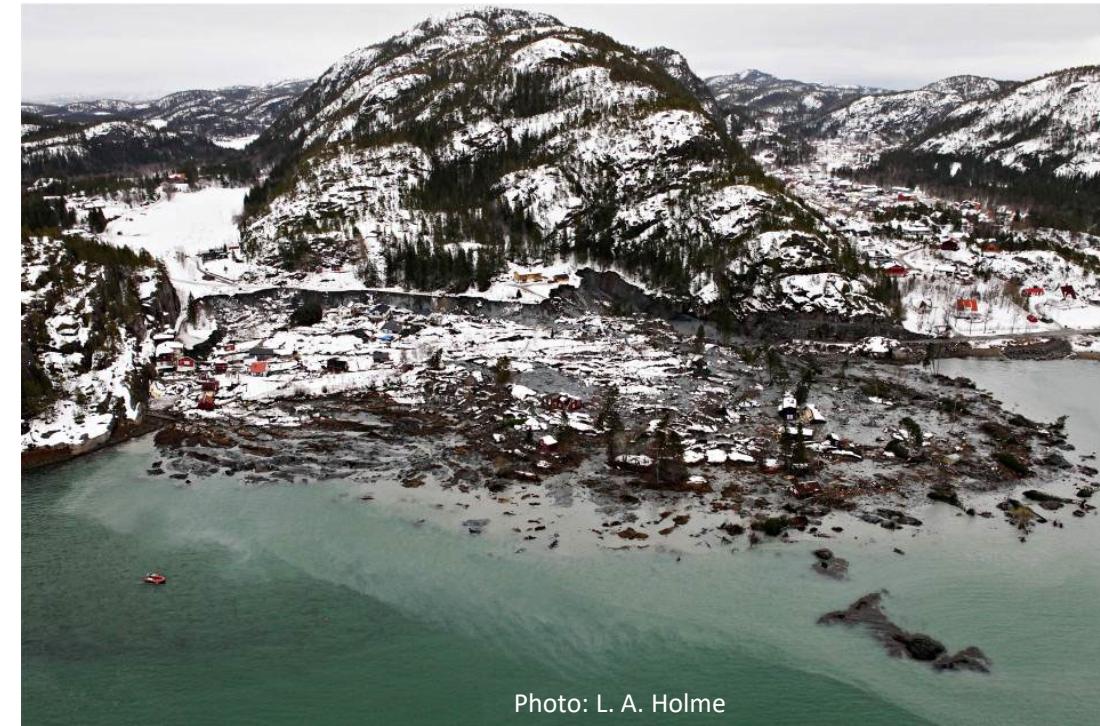
- Blasting of rock as part of road construction (near quick clay slope)
- Initial slide started immediately (after ca. 0.5 min) and the entire slide activity lasted 6-10 min after blasting
- Destroyed 4 permanent houses and 6 summer residences. 7 persons rescued unharmed.
- Slide volume $300\text{-}500 \times 10^3 \text{ m}^3$
- A stein block that landed on the slope remoulded the adjacent quick clay material (initial slide!)

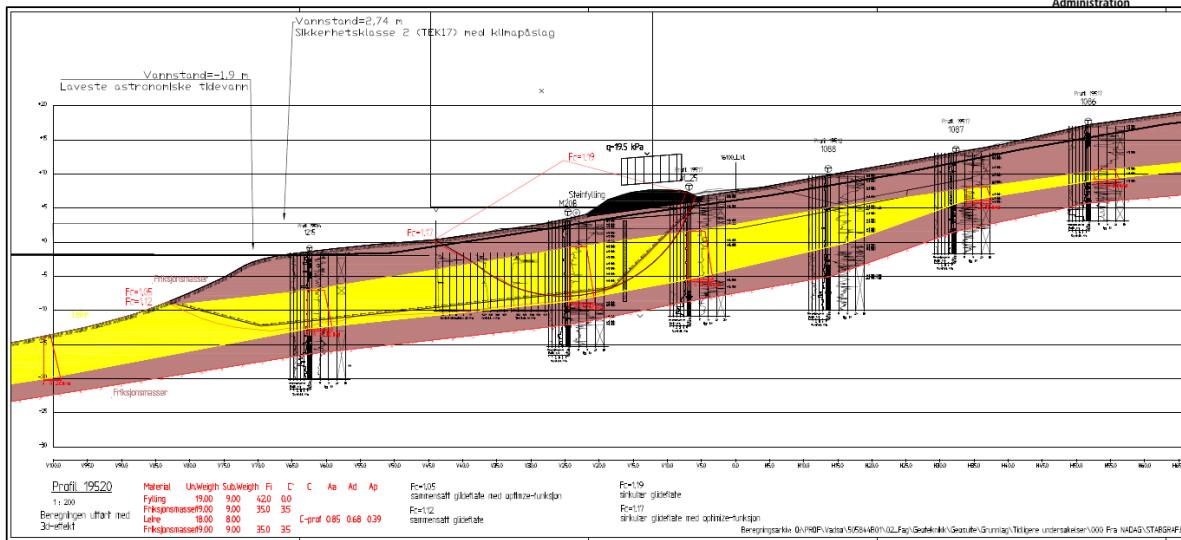
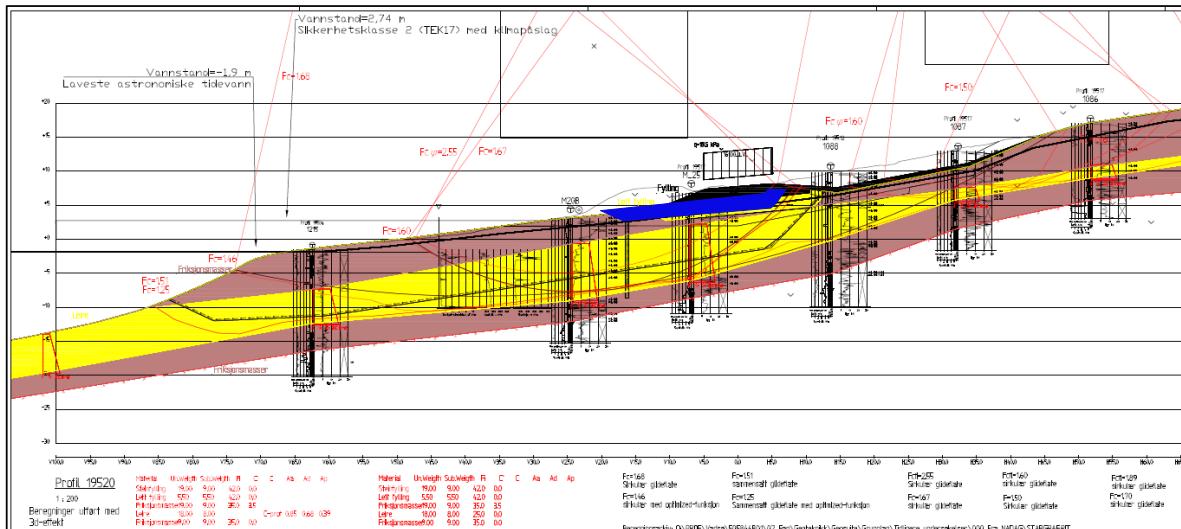
- Existing stability condition gave a factor of safety lower than the requirements (N200)
- Improvement measures (road moved slightly inwards) – mass replacement with light fillings + terrain unloading
- Design control by independent 3.party => similar improvement measures

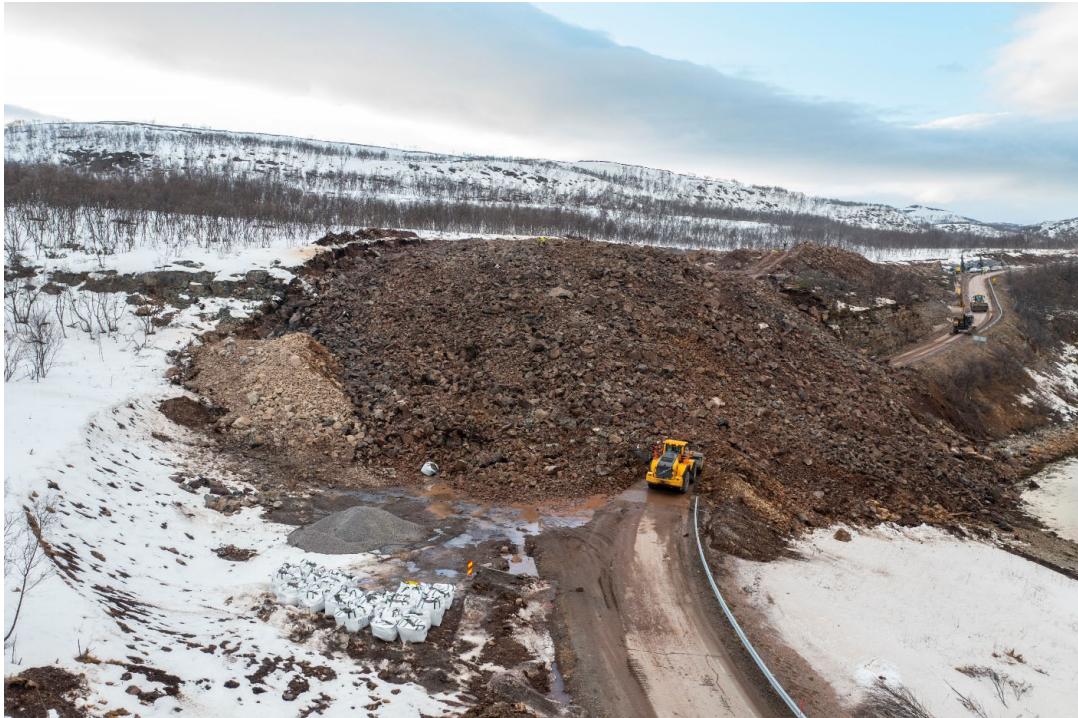
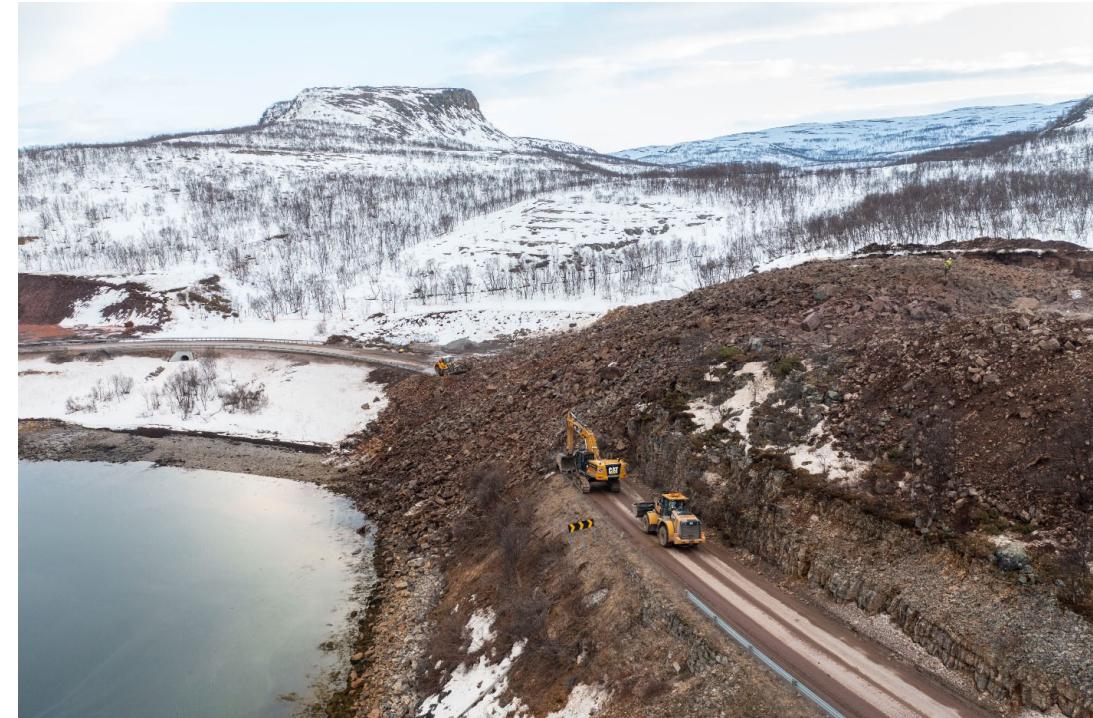
- Blasting carried out in 3 phases – First ca. 1000 m³ and second ca. 5000 m³
- The 3rd blasting involved mass of ca. 40 000 m³, executed 17.04.21 kl. 18:13 – resulted in 10-15 000 m³ blast material on the road

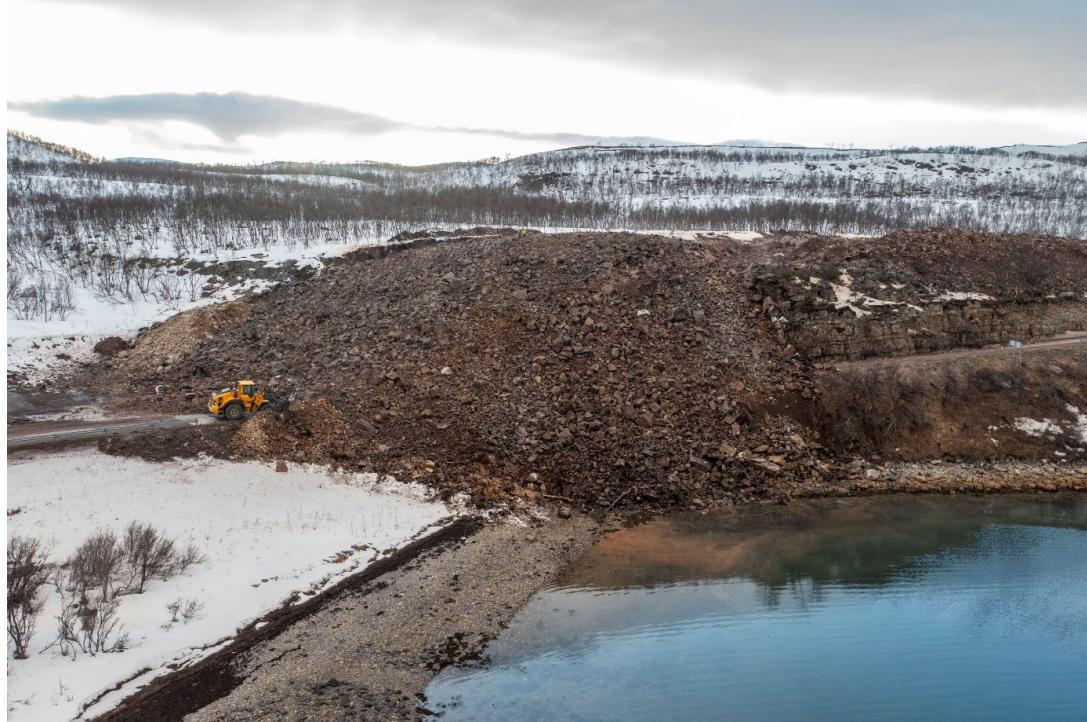
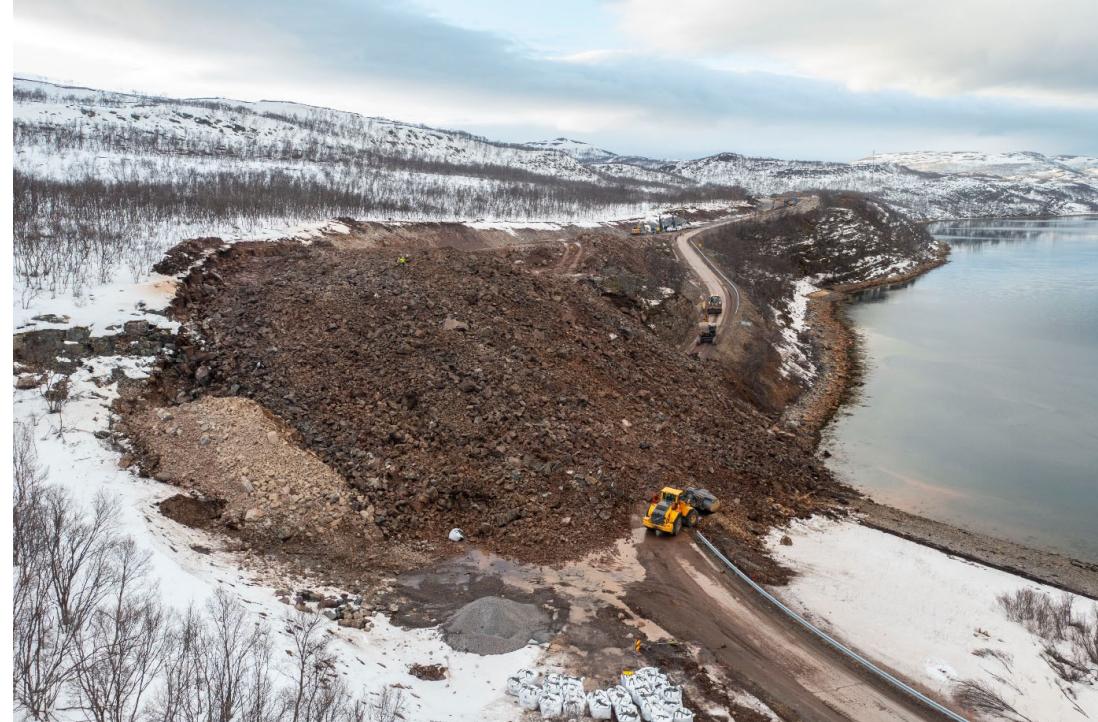
- Activity to open re-open the road started immediately after basting and lasted till kl. 01:00

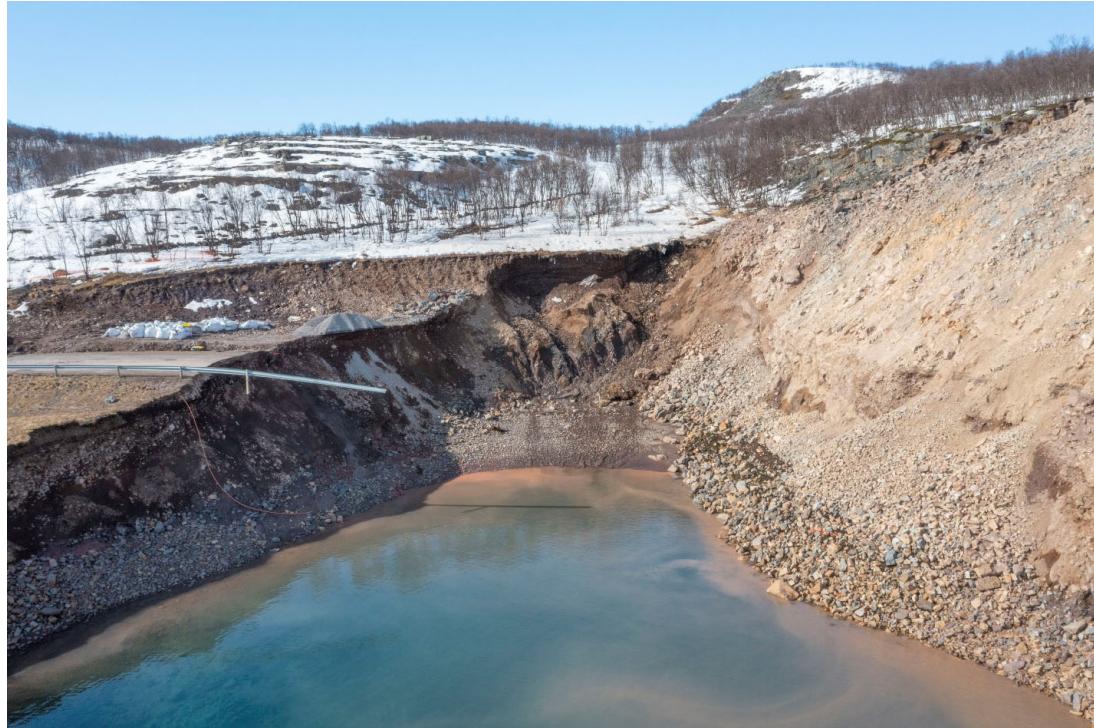
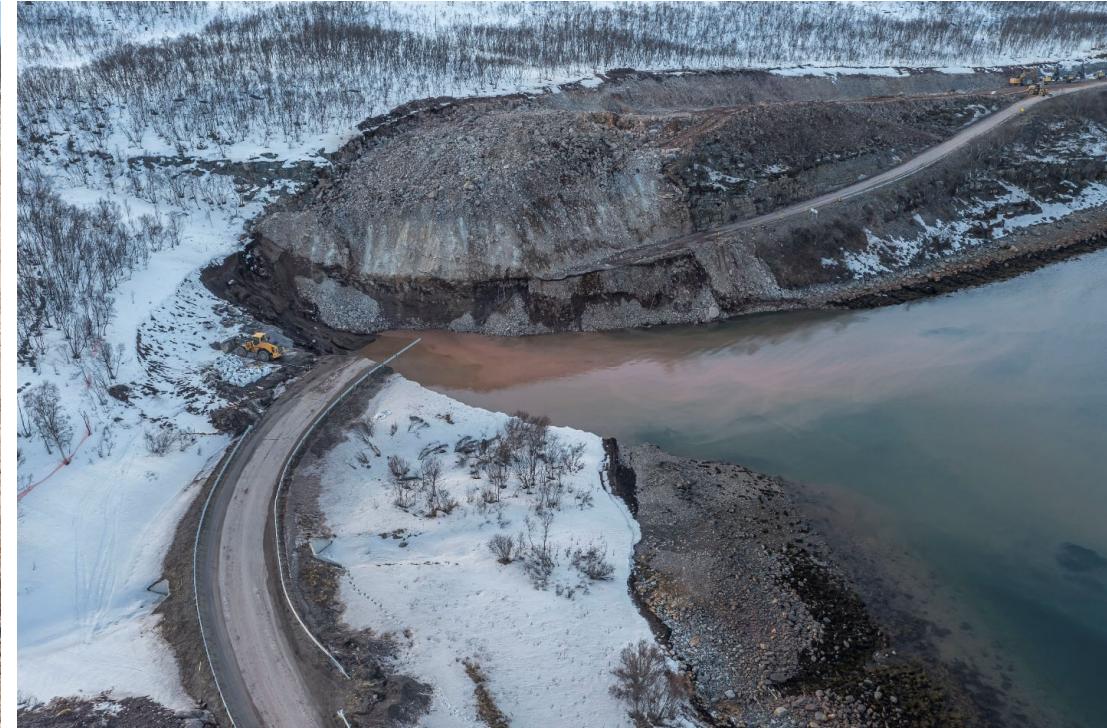
- The slide registered at Traffic Control Centre (VTS) @ 03:33 AM –
- Occurred between 01:00 AM and 03:00 AM – at least 6.75 hours after blasting
- The slide took 50 m of the road section.

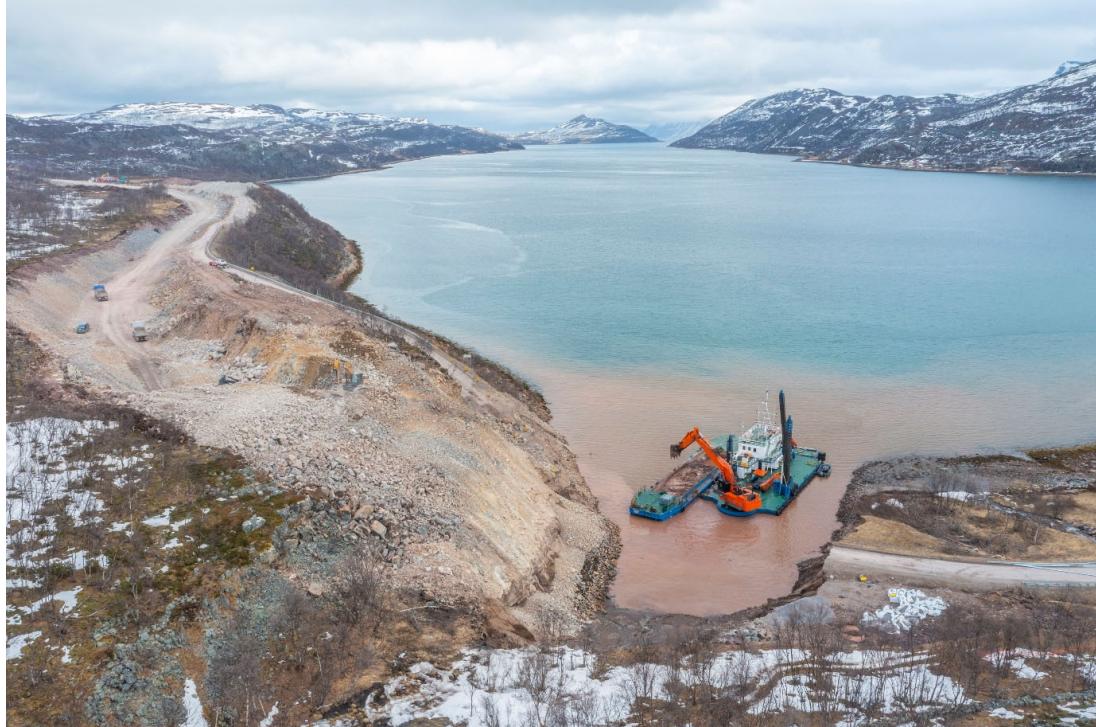
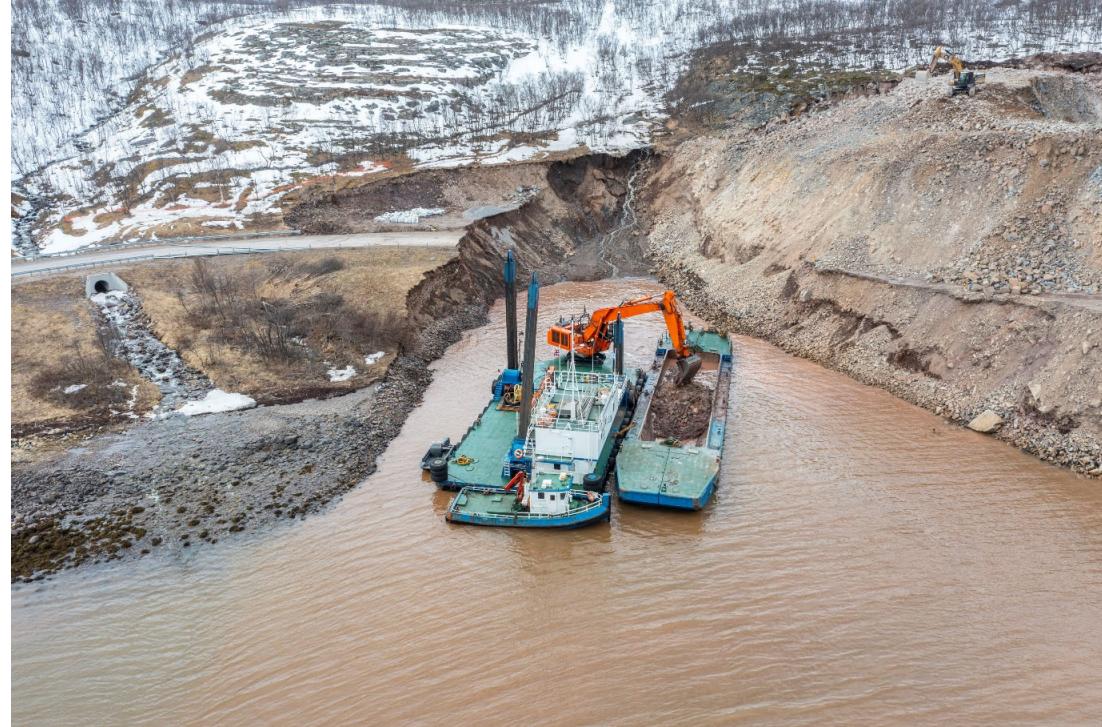
- Road closed for 2 months => detour length of ca. 500 km, direct cost of ca. 18 mill. kNOK
- Slide materials excavated and replaced with crushed rocks

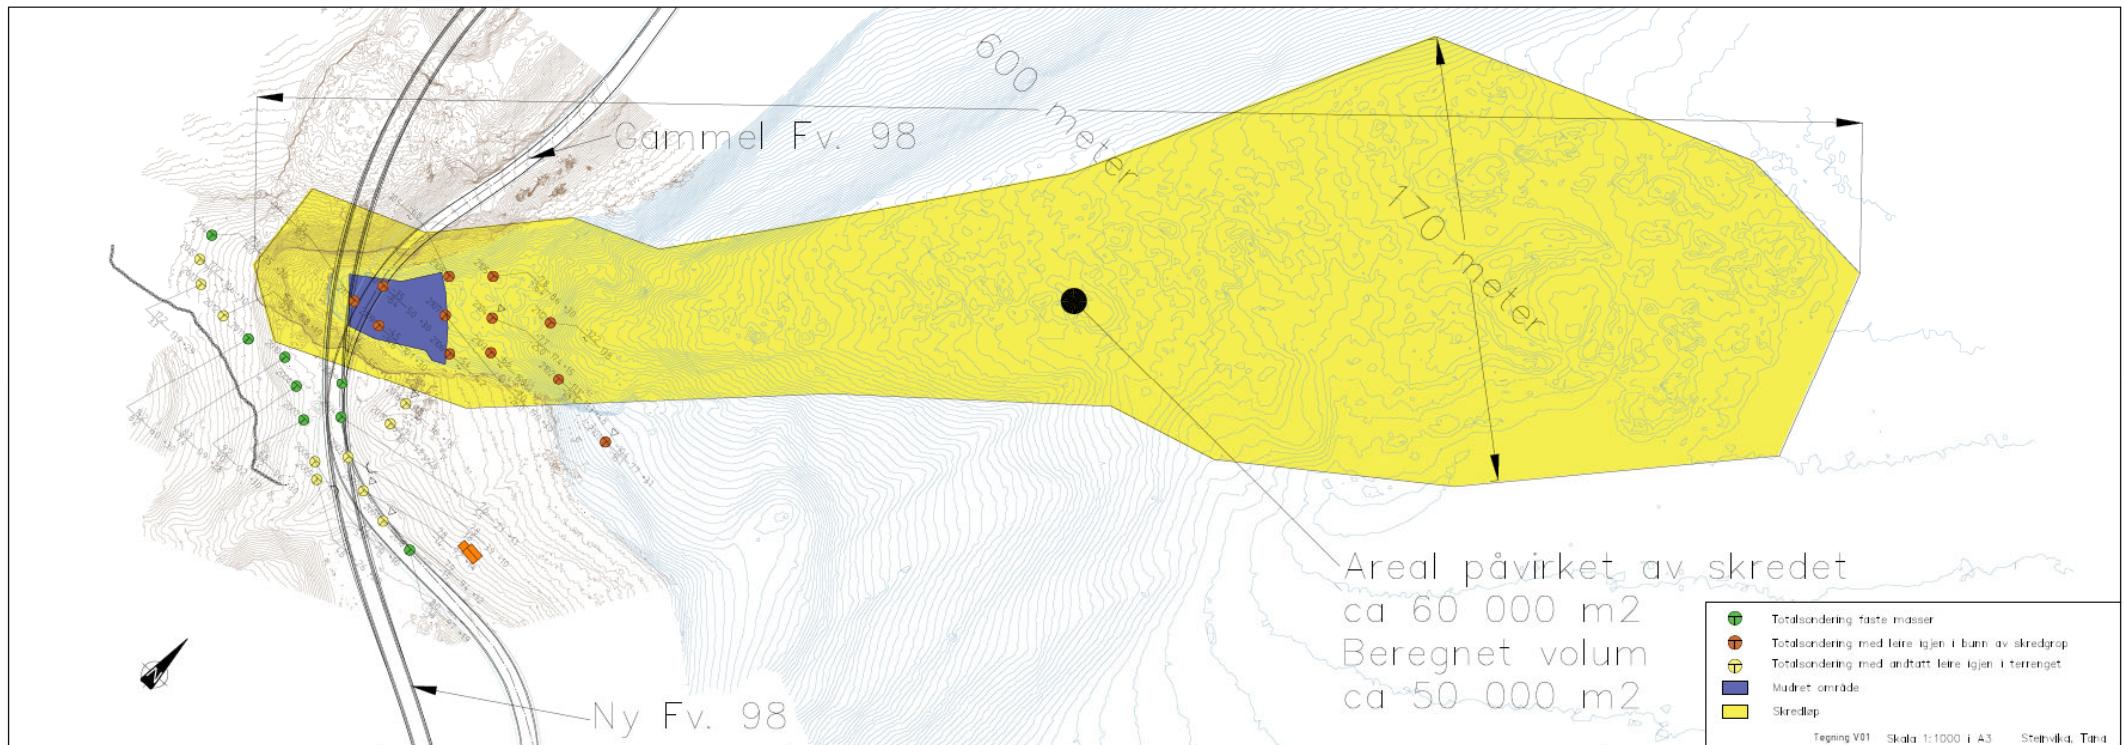
- Retrogression + runout distance of the slide = 600 m
- Resulting slide volume 60 000m³

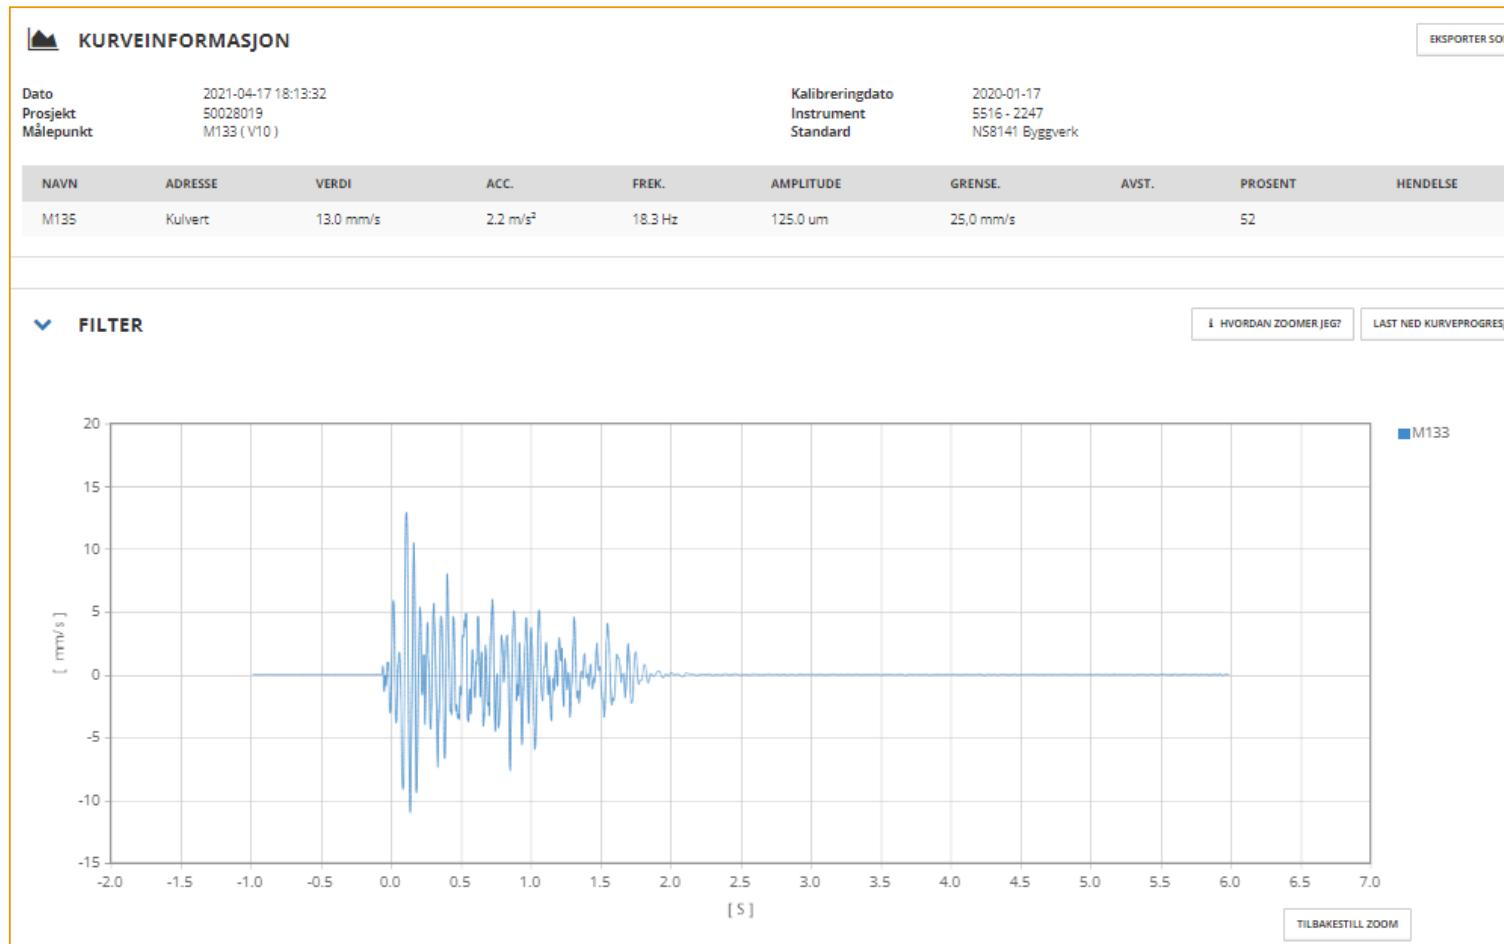
- Peak value 13 mm/s, 18:13:32
