Blast triggered landslide at Steinvik, Tana, Norway

Samson A. Degago

The Project Fv. 98 Torhophøyden – Smalfjordbotn (98 MNOK)

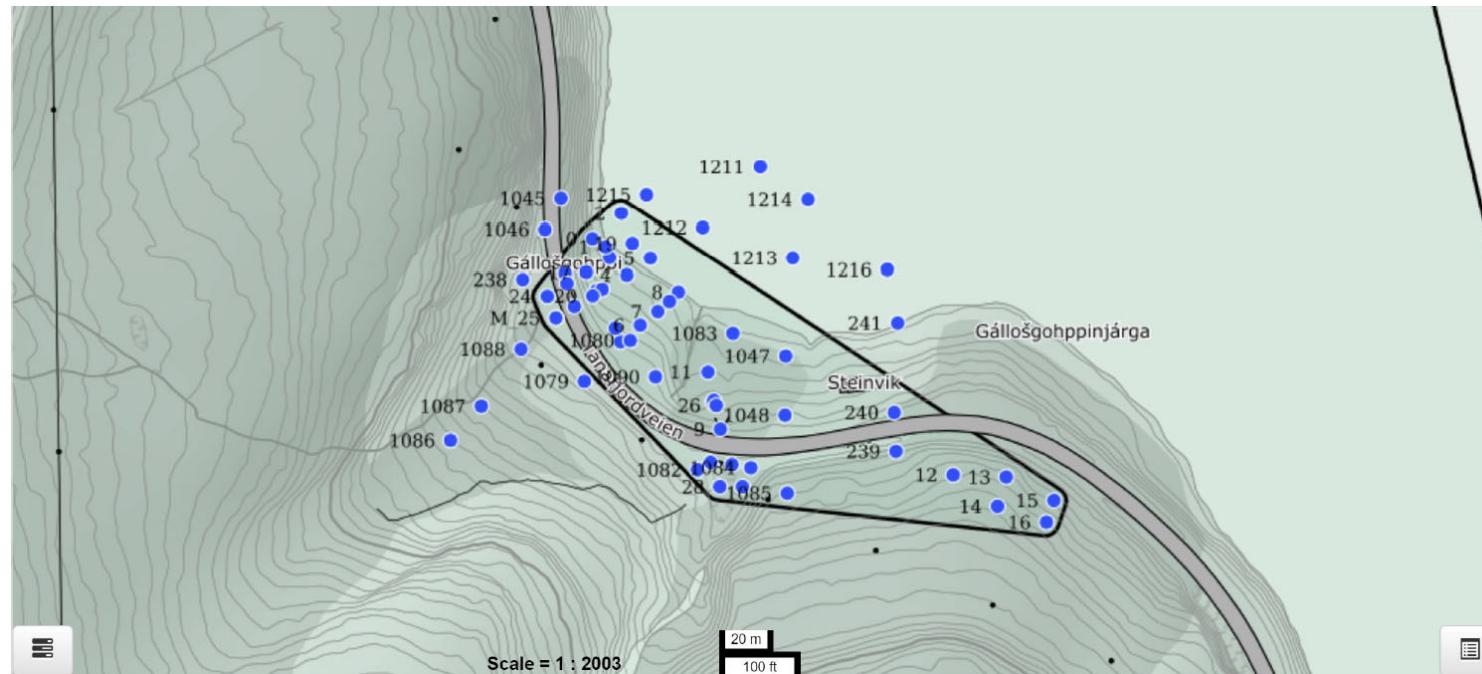
- Steinvik is 150 m wide cove under marine limit
- Total soundings, CPTu, Sampling
- 0 - 25 m thick soil layer – sandy gravel layer (5m) over silty clay and clay of varying shear strength (25 – 37 kPa)
- Contains highly sensitive clay layer – quick clay

Soil investigation points registered in NADAG (National Database for Ground Investigations).
(geo.ngu.no/kart/nadag-avansert/)

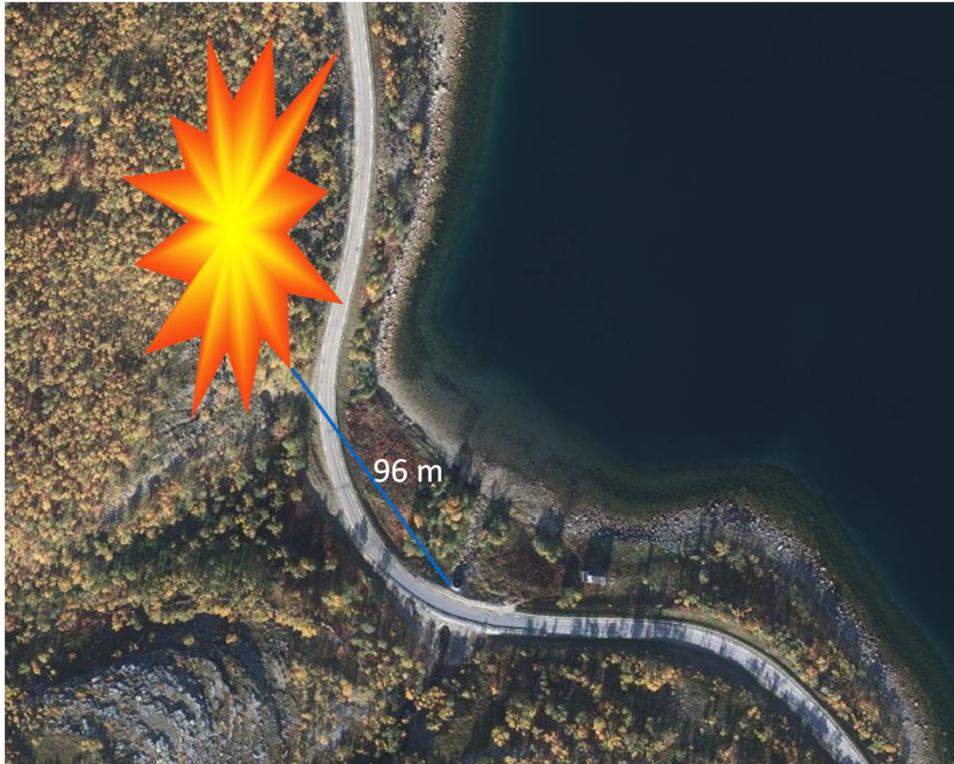
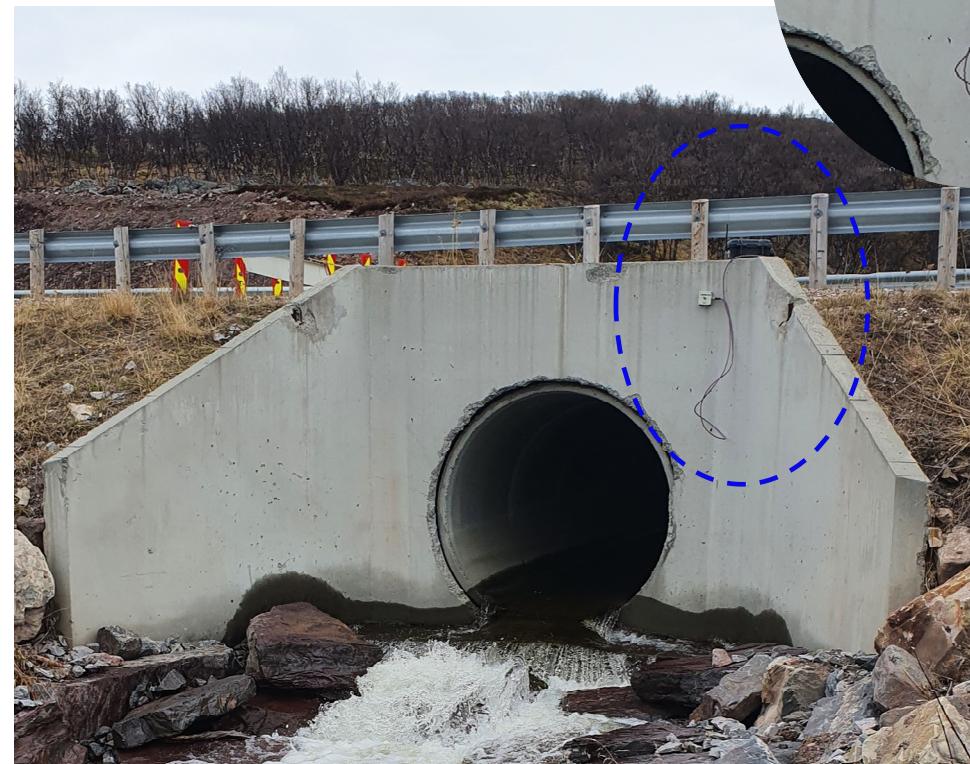
Vibration measurement

- 1 Vibration measurement
- Device mounted on a culvert located ca. 90 –100 m from blasting area
